AMENDED REPORT OF INVESTIGATION
Surface Coal Mine

Fatal Electrical Accident
August 29, 2004

Williams Electric (N47)

Hobet 21 Surface Mine
Hobet Mining, Inc.
Madison, Boone County, West Virginia
I.D. No. 46-04670

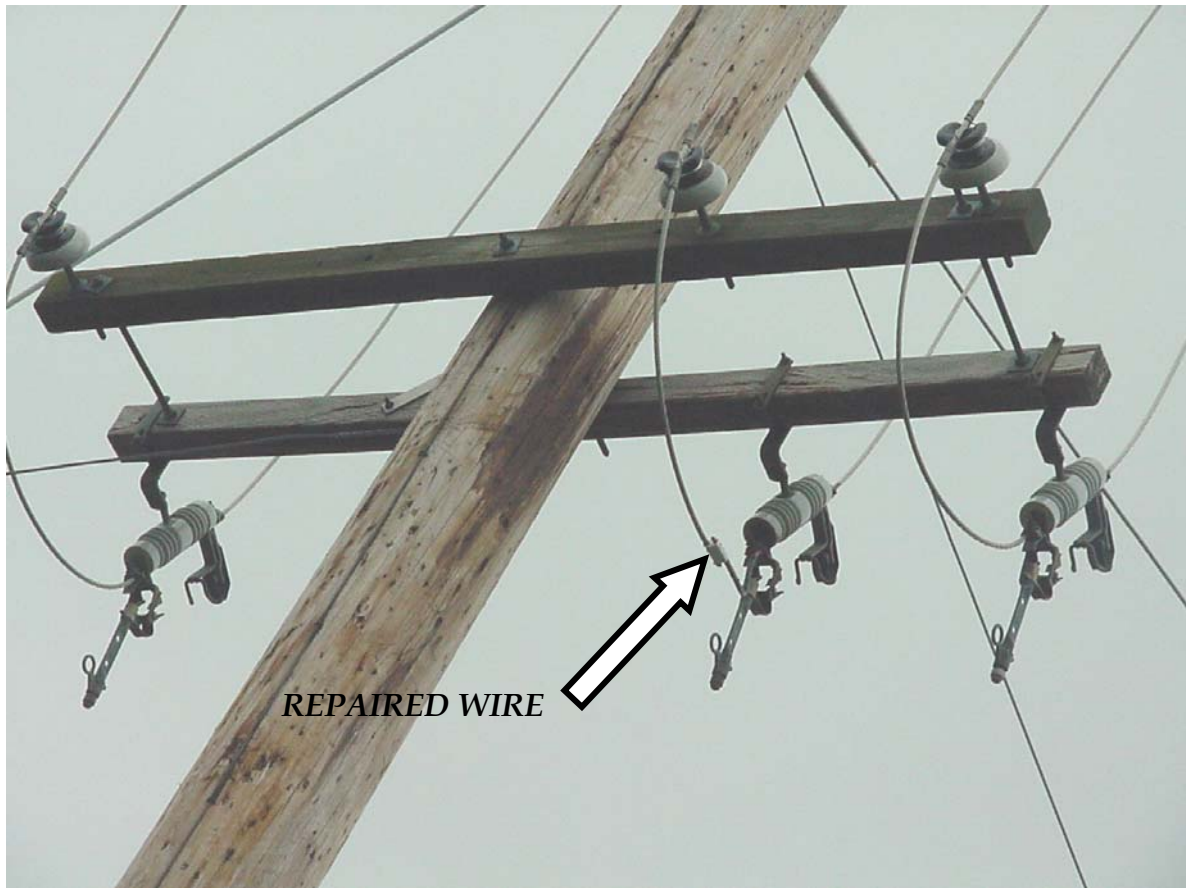
Compton and Copley, arriving at the Pit 18 power pole, observed the burned wire at the bottom of the pole mounted disconnect. They proceeded to work without notifying Hobet 21 Surface Mine (Hobet 21) personnel. Compton retrieved the hot stick, an insulated tool used to open and close certain pole-mounted disconnects, from the service truck and pulled the cut-outs (disconnects) open. Compton retrieved a piece of copper wire out of the truck and peeled the

The high voltage power was deenergized at the set of disconnects mounted on the same pole where the repair work was performed. The sole use of these disconnects was not appropriate because this caused the repair work to be conducted in very close proximity to energized high voltage components. The repair work consisted of entering a piece of copper wire into the mounting device on the bottom of an insulator which is part of the disconnect, and splicing this copper wire to the existing line. The contract employees passed two locations where the high voltage power could have been deenergized, locked and/or tagged, while traveling to the site to conduct the electrical repair work. They passed a substation located approximately ½ mile from the work site, and also passed a set of disconnects mounted on a power pole approximately ¼ mile from the work site. The disconnects located ¼ mile away were inaccessible. Shrubbery and brush had grown around this pole making them unable to be used.

The victim performed the electrical work within close physical proximity to energized high voltage power (approximately 11" from 12,470 volts). The line side of the disconnect where the copper wire was entered into the clamp of the insulator of the center disconnect was energized. Compton, Foreman for Williams Electric, stated that it was more convenient to deenergize the immediate disconnects than to bother anyone else to make the repairs. Compton and a Williams Electric supervisor, Harry Smith, stated that it was normal company policy to perform repairs this way. They stated that the procedure is appropriate, that they train their employees to do it this way, and that they would do it again that way. Making the repairs in this manner would only take approximately 30 minutes. Compton, while working with Williams Electric on Hobet Mining Properties, had knowledge of the lay-out of the high voltage power lines, disconnects, and other electrical installations. Compton knew that it would take longer to locate Hobet personnel and deenergize power at another location than to just deenergize the immediate disconnects and complete the repair work. After opening the disconnects, Compton did not properly ground the deenergized end of the high voltage line before work was performed on the broken high voltage wire.
